# Manhole Inspection Summary

Manhole # S25C1\_013MH

**Location** Address: **2444 NEVADA ST.**

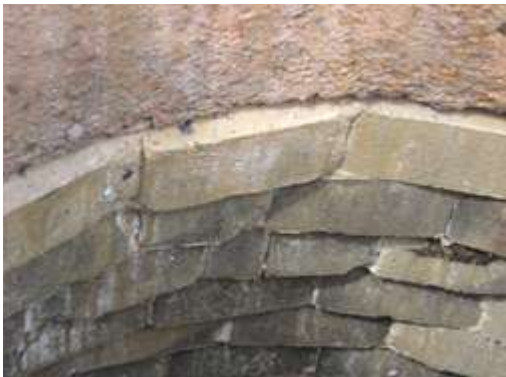
Defect 1

Infiltration: ☐ None ☐ Joint ☐ Cracks ☒ Mortar ☐ Roots ☐ Wall

MISSING MORTAR BETWEEN FRAME AND CHIMNEY, AND INFILTRATION EVIDENCE.

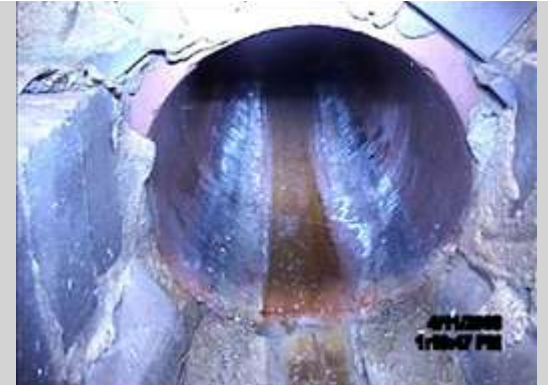
12 O'Clock Outflow

8 in. Circular Gravity Sewer  
Pipe Out @ 12 O'Clock

Infiltration: **None** Pipe Seal Cond: **Sound**

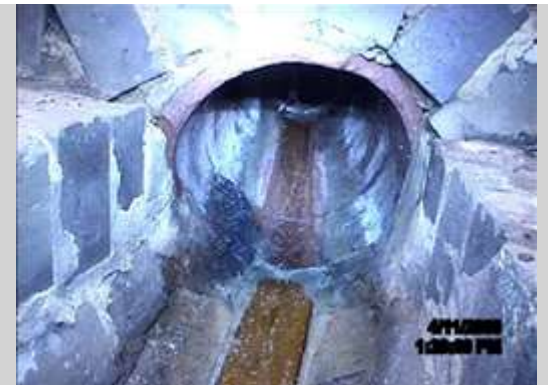
3 O'Clock Inflow

8 in. Circular Gravity Sewer  
Pipe In @ 3 O'Clock

Infiltration: **Evidence** Pipe Seal Cond: **Sound**
